Friction Factor Tests on 300 mm High Density Polyethylene Pipe

Hydraulic Report No. 224

**FRICTION FACTOR TESTS ON 300mm
HIGH DENSITY POLYETHYLENE PIPE**

Hydraulics Report No. 224

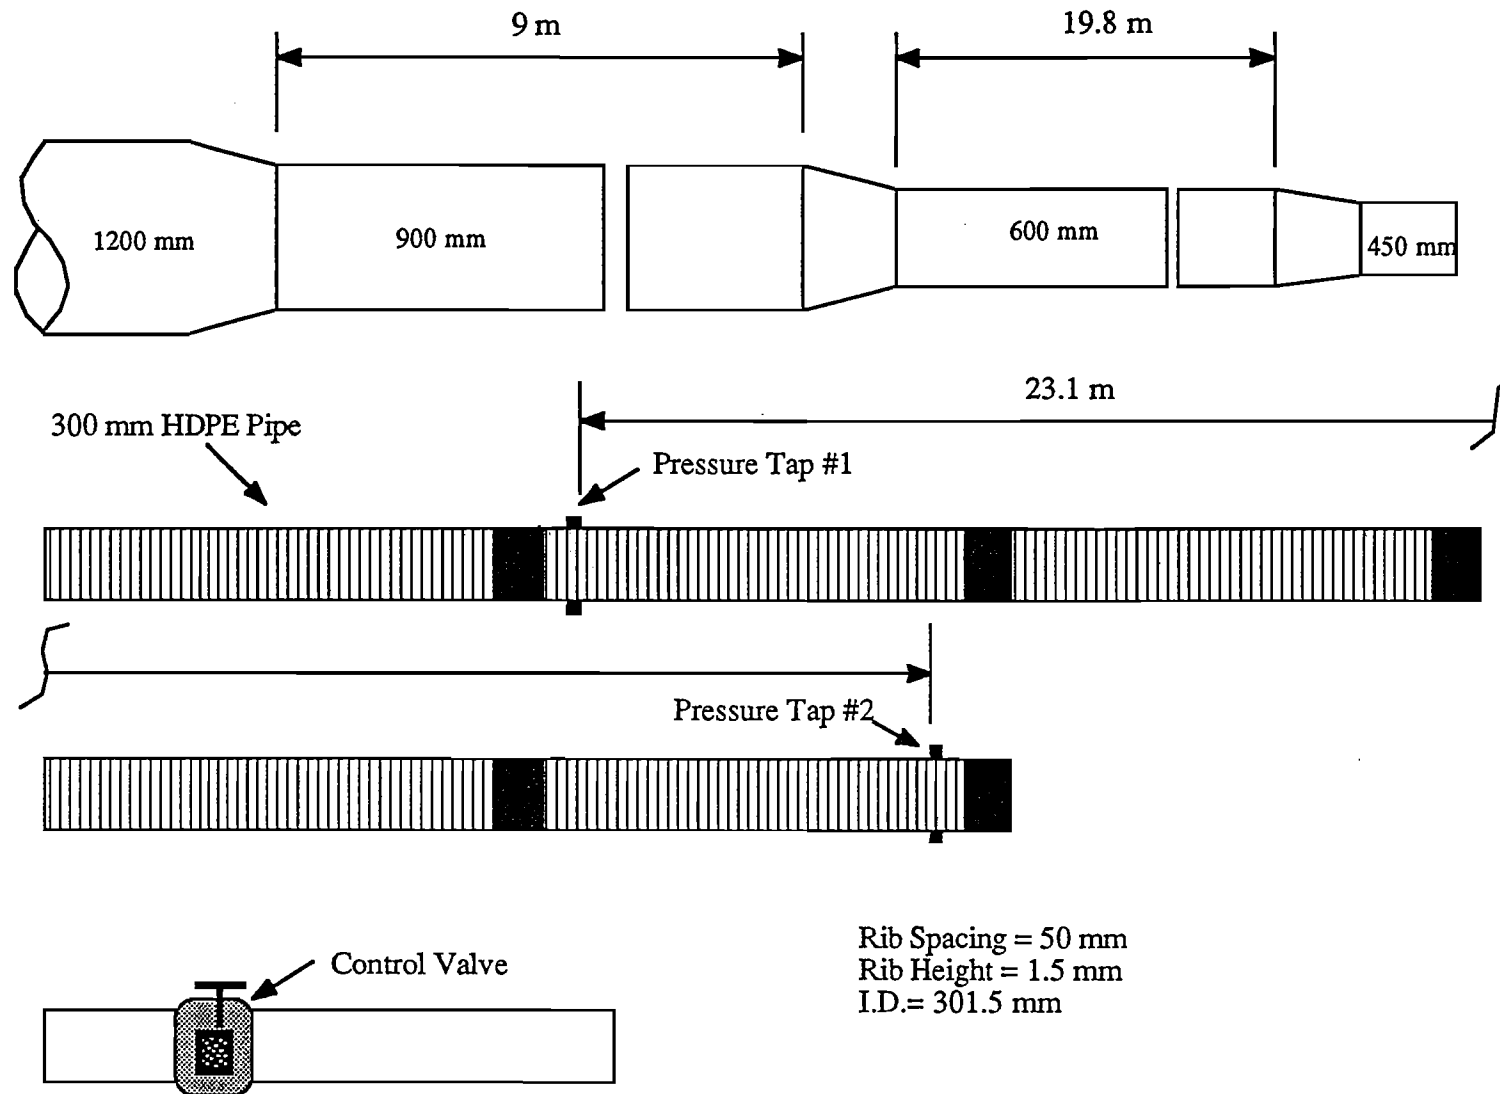
300 mm HDPE Pipe Setup

Figure 1 shows the installation of the test pipe. Water was supplied through a 1200mm pipeline by gravity flow from a small reservoir; the pipe tapered off to 450mm upstream from the test section. To establish a fully developed flow upstream from the test section, one length of HDPE pipe was installed downstream from the 450mm laboratory steel pipe. The length between pressure taps for the test section was 23.1m (see Figure 1).

Pressure was controlled using a 1200mm butterfly valve which was installed in the main supply line. The flow was controlled and the pipe kept full by using a 300mm butterfly valve which was located downstream from the last test section. To prevent rupture of the CANUSA wrap, it was necessary to limit the pressure head in the pipe to approximately 4m.

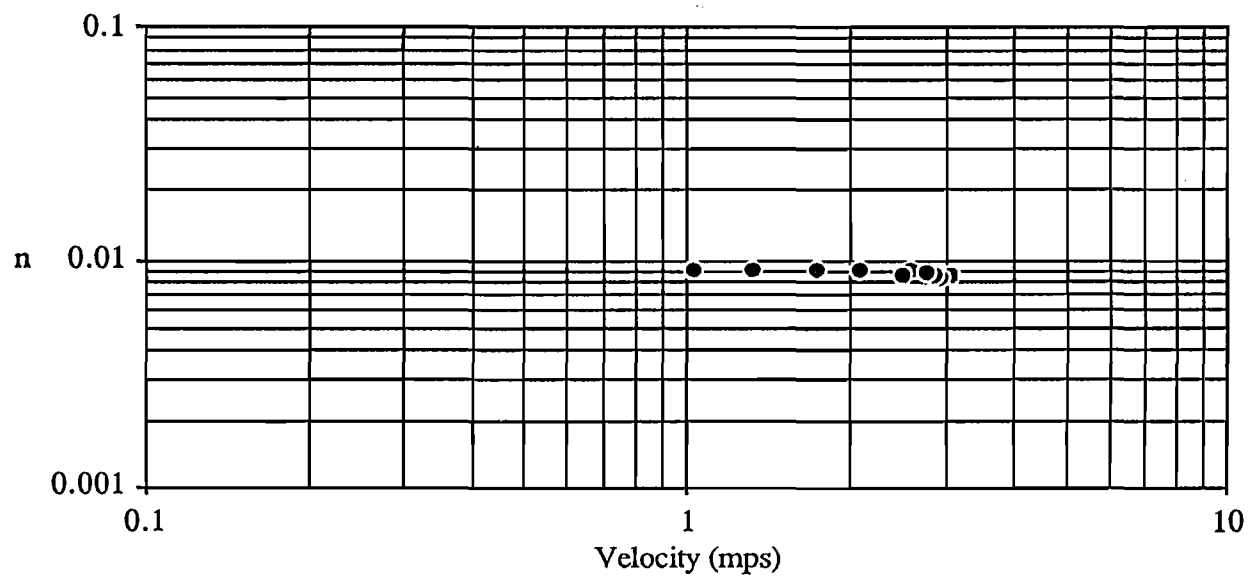
Manning n vs. Velocity for 300mm Diameter HDPE Pipe
Figure 2

Experimental results for the three sets of tests are contained in Table 1 and Figures 2-3. Plots are provided of the variation of the Darcy-Weisbach friction factor f versus velocity and the Manning's n versus velocity. (To calculate the average velocity, the diameter of the pipe was consistently measured at the corrugation peaks.)

Note that the Manning's n varies from 0.0090 to 0.0083 corresponding to a velocity variation of 1.0 to 3.0m per second. Additionally, the friction factors decrease slightly with increased velocity.

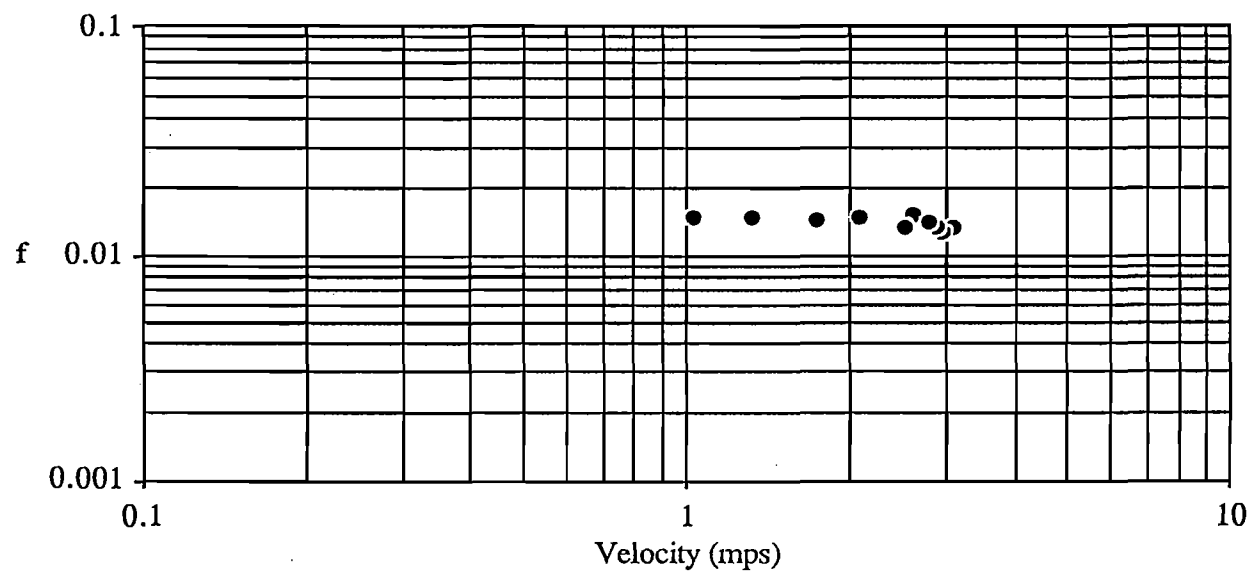
Friction f vs. Velocity for 300mm Diameter HDPE Pipe
Figure 3
